Banaba, Kiribati Asbestos Assessment

1. Background

On the 29 of May 2022, the Environment and Conservation Division Team conducted an asbestos assessment at the three priority buildings in Banaba. This was part of the Pacwaste Plus project administered by SPREP. The inspection was focused on three public buildings namely; Banaba Hospital, Junior Secondary School and Primary School and Fatima Catholic Church. The three buildings were selected based on the criteria for EU funding of Pacwaste Plus project. This was agreed by the ECD and Banaba team made of Island Clerk, MP – Tibanga Taratai, and Rabi Council of Leaders Island Manager Mr. Mwaroti Tamueru at the meeting held on the 2nd meeting 11 May 2022.

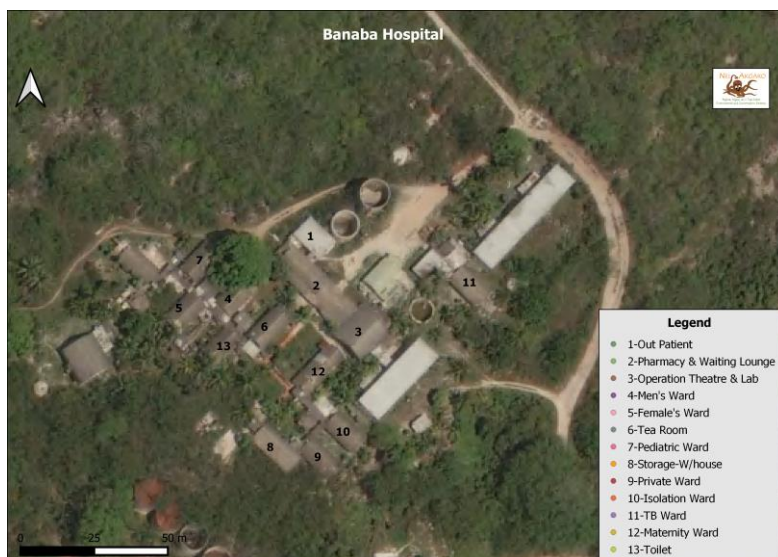
Figure 1. Banaba Hospital

As shown in the photos below, the hospital is made of 13 structures, each around 30m long and 13 m wide. During the inspection, the team was told that only 1 building is currently occupied by Agriculture Assistant staff of Agriculture and Livestock Division. The majority of the ACM are found in roofing (including ridge cap and guttering), drain pipes, and in internal and exterior wall panel. The area is covered with large and small ACM fragments as shown in figure 3. It is important to note that building or structure number 4,5,6,7,9,10, and 12 as shown in figure 1 are relatively similar in size and design. Based on the type of ACM and PACM used in the hospital buildings, the estimated quantity of ACM summed up to 3,255 m².

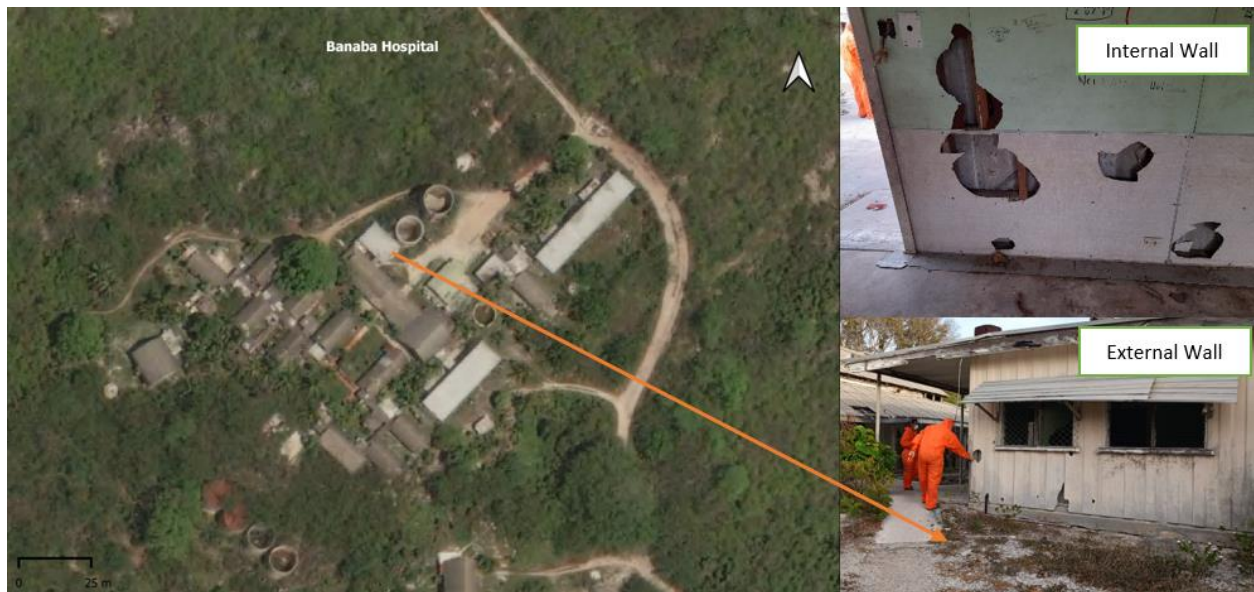
The building contains used asbestos containing material (ACM) and PACM in internal and exterior wall. The roofing is aluminum. The internal wall, particularly the lower part of the wall appeared to be PACM and they are badly damaged with holes in them. The exterior wall observed to be similar to that used at the Primary school that previously confirmed to contain asbestos in the 2014 asbestos survey.

Figure 2. Out Patient – Number 1 as indicated in figure 1.

Based on the type of asbestos found in the building, the building structure estimated to have contained about 180.96 m² exterior wall cladding and 14.82m² from internal wall.

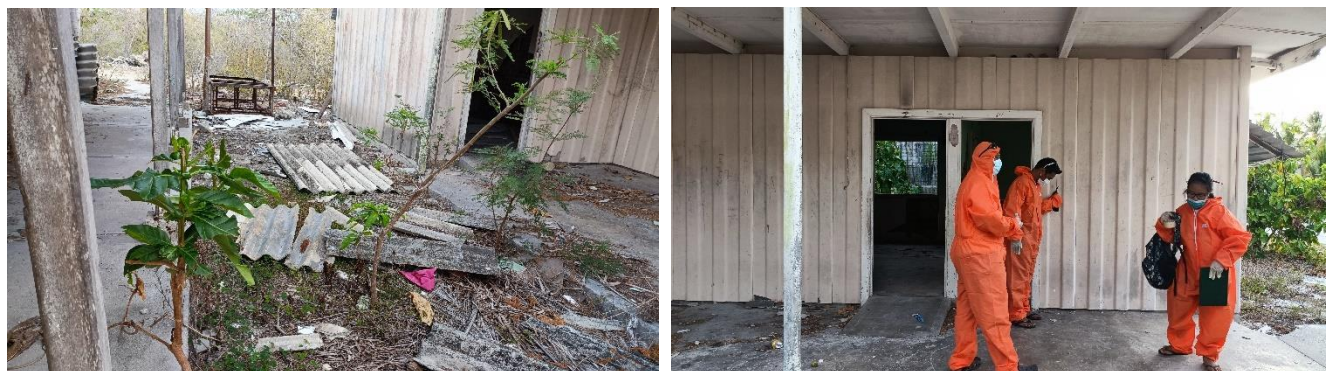
Figure 3. Look ACM roof near the outpatient building which believed to have come off from main building

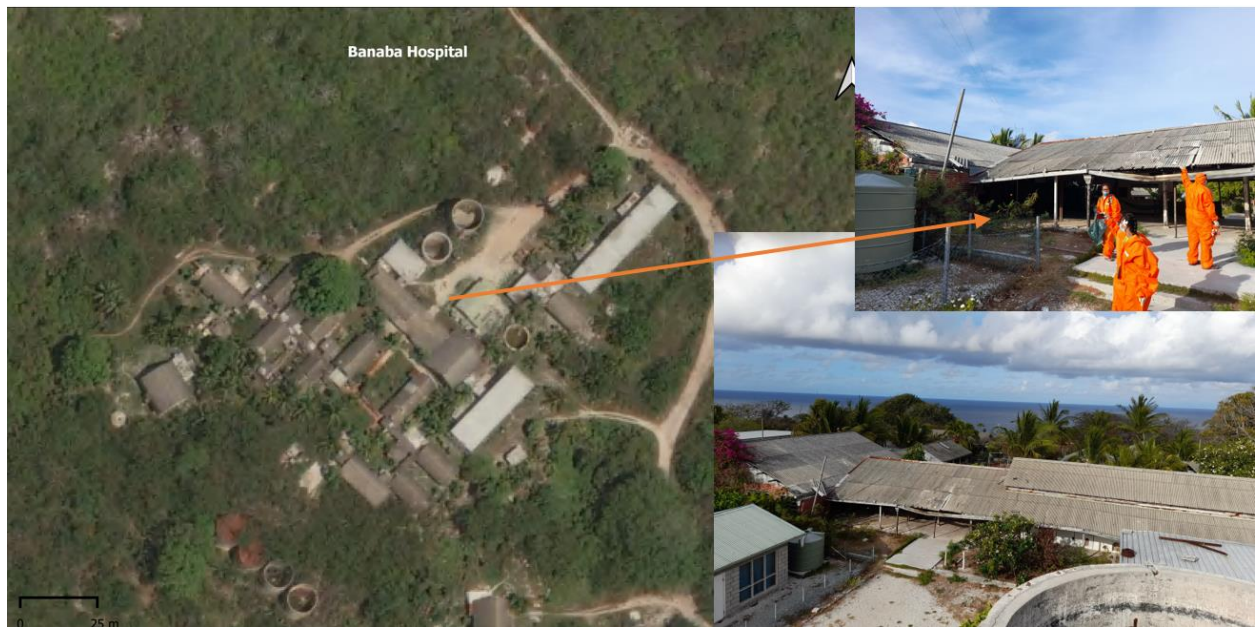
The building contains two structures, the Pharmacy and contains asbestos and PACM in roofing (including ridge cap and guttering) and side ceiling. The ACM roofing is significantly damaged. There are loose ACM materials that appear to be fragment of broken roofing scattered around the buildings.

Figure 4. Pharmacy and Waiting lounge (orange arrow shows the direction where the photos is taken from).

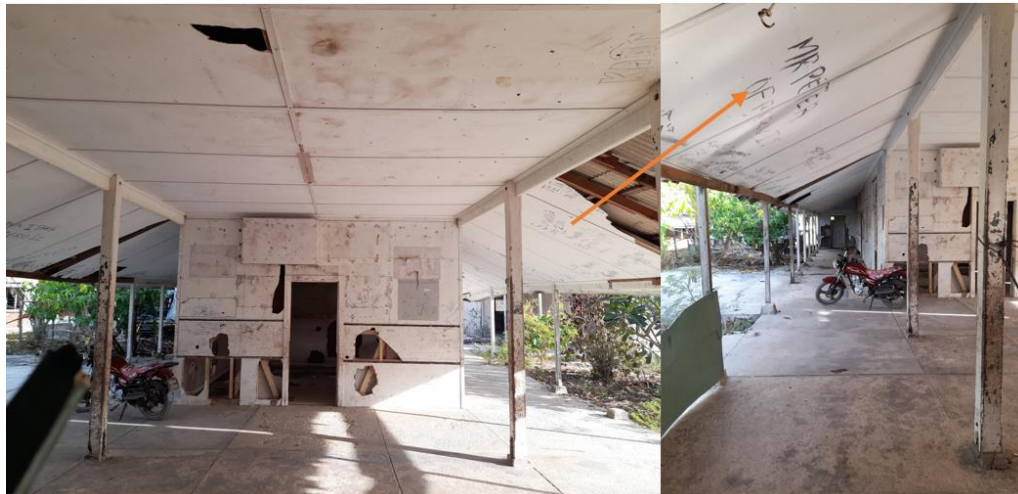
Figure 5. Side ceiling are ACM. The photo on the right show ACM ceiling.

Figure 5 above is the view from inside the waiting lounge showing two side ceilings. The photo on the right is an example of ACM side ceiling. The ceiling in the middle is not asbestos but **mesonite**. There are holes in the ACM ceiling. The ceiling frame is very old and there are signs of delaying.

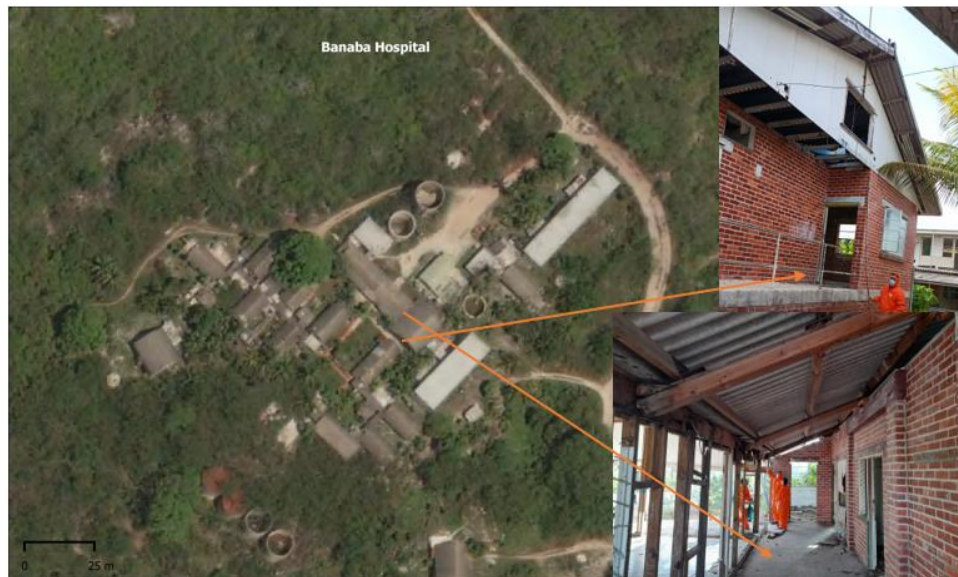
Figure 6. Operation Theatre

The only ACM observed in the building is the roofing, ridge cap, guttering and drainage pipes. The side panel as shown in the top photo in figure 6 is ACM. The same ACM panel is also use in opposite of the building. The building is constructed using concrete blocks, not ACM use in internal walls. There some broken roofing observed especially from inside the building. The ceiling timber frame appeared to be very old and show signs of decaying.

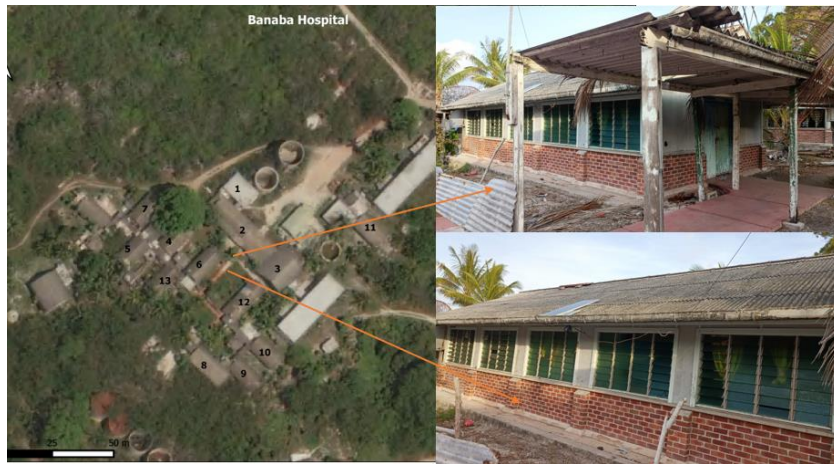
The ACM found in this building is roofing, guttering, drainage pipe, and walk way roofing as shown in the top right photo in figure 7. As shown in the figure 7 below, buildings indicated as numbers 4,5,6,7,9,10, and 12 are similar in design and size with various conditions of ACM used in each structure. All the seven have ACM roofs which are observed to be in good condition except for building number 12, farmer maternity ward where some of the roof panels are badly damaged. Some of the roofs have been replaced with aluminum roof sheets as indicated in figure 8. Most of the building's external wall cladding have minimal to no damaged observed. The internal wall claddings as shown in figure 8 contains asbestos which the same used in other buildings. Figure 8 shows that building number 12 are badly damaged with holes in them. There are also loose ACM scattered around the building which appeared to come from broken roofing of the walkway.

Figure 7. Tea room and photo of the walkway with ACM roofing and guttering.

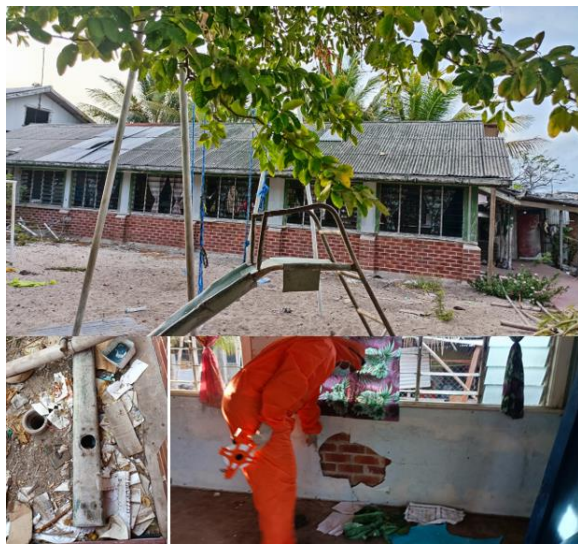
Figure 8. Former Maternity ward; photo on bottom right shows broken internal wall cladding and ACM drainage piping on bottom left

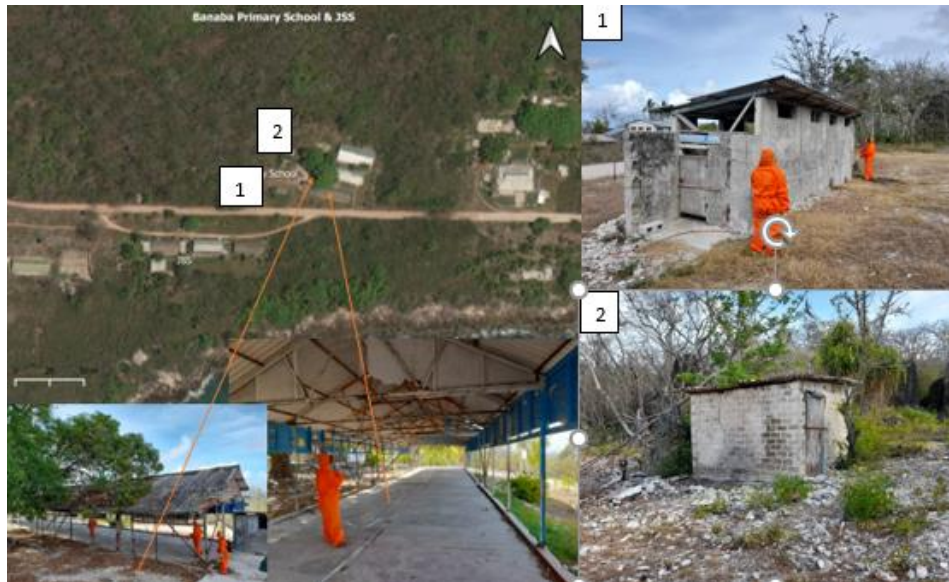
The primary school is situated close to the main road as shown in figure 9. The former primary school classroom or building is no longer used by the school but was used occasionally for school gatherings or functions. The results of the inspection confirmed that the ACM are used in old classroom roof, toilet roof and storage roof.

Figure 9. Primary school; and toilet marked at 1 and storage room marked as 2 in photo below

There is a pile of small fragments of ACM near the storage room which appeared to be a broken roof. Small debris of ACM are also observed near the storage room and toilet. The ACM roofs of the three structures are in condition except for classroom where broken edges are observed as indicated in figure 10. A preliminary estimate of quantity ACM used in school is more than 382m².

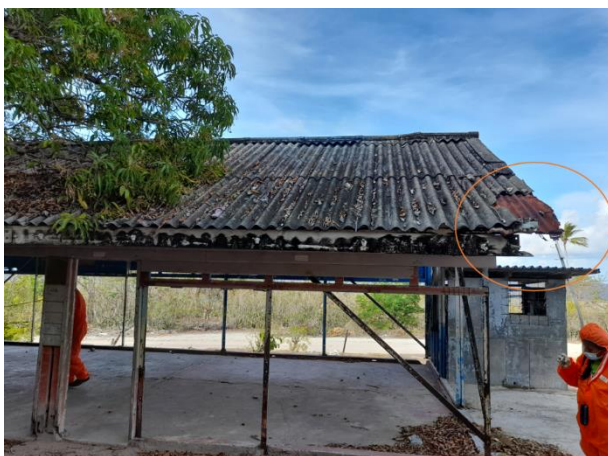
Figure 10. Former Class from with broken roof at the end; replace with aluminum roof as circled in red

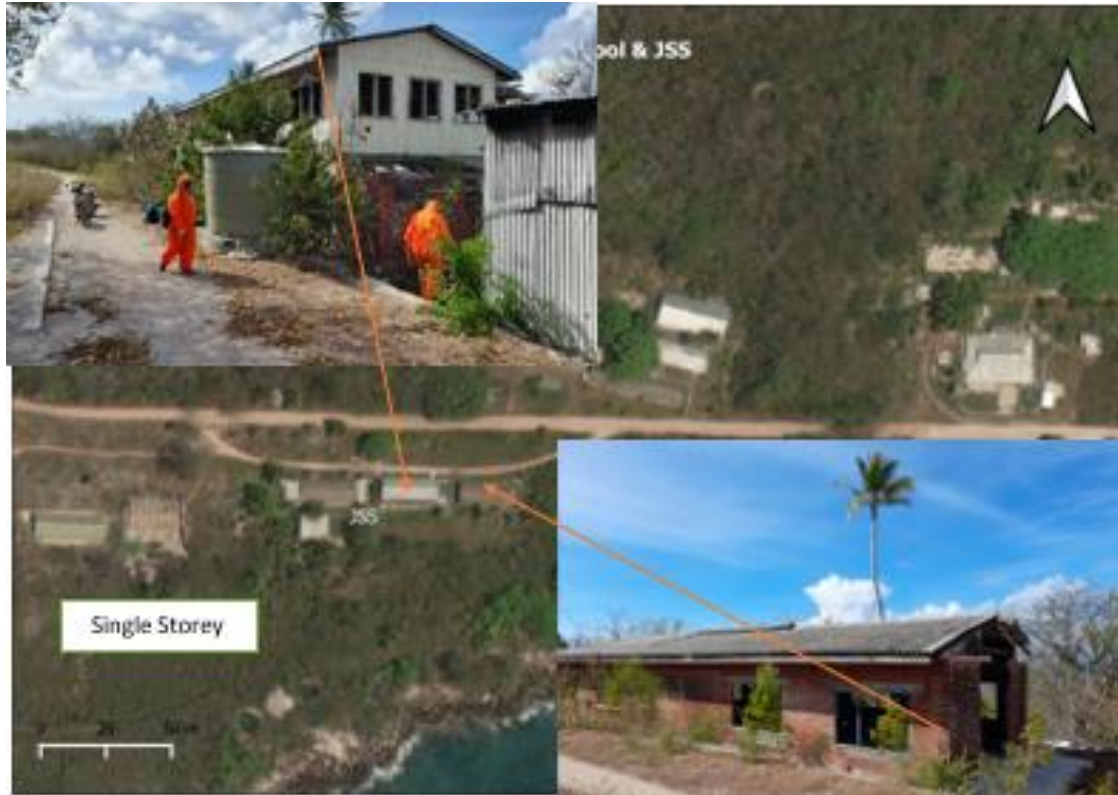
Figure 11. Junior Secondary School

The school consists of two buildings, double and a single storey building. The single storey has ACM in its roofing as shown bottom right photo in figure 9. The roof is in good condition. The double storey building is constructed with brick with ACM cladding. The cladding is in good condition with minimal damage observed indicated in figure 13. The building roof is made of aluminum roof, however, the varander has ACM roof as shown in figure 14. The top varander of the double storey has ACM roof and they are in good condition.

Based on the type of ACM found in the JSS buildings, it is estimated that the ACM found at JSS is more than 195.96 m².

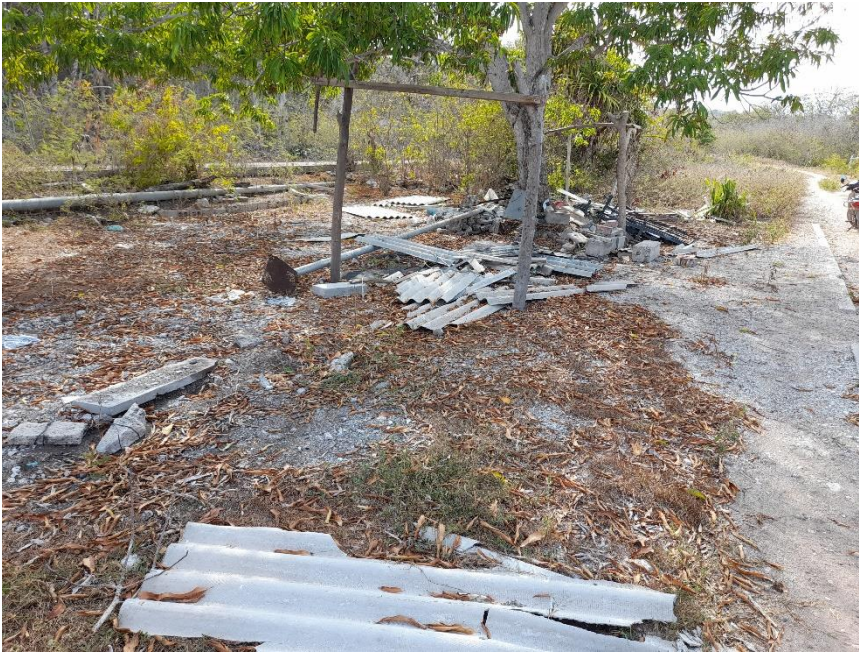
Figure 12. Large debris of ACM near the JSS believed to have come from double storey

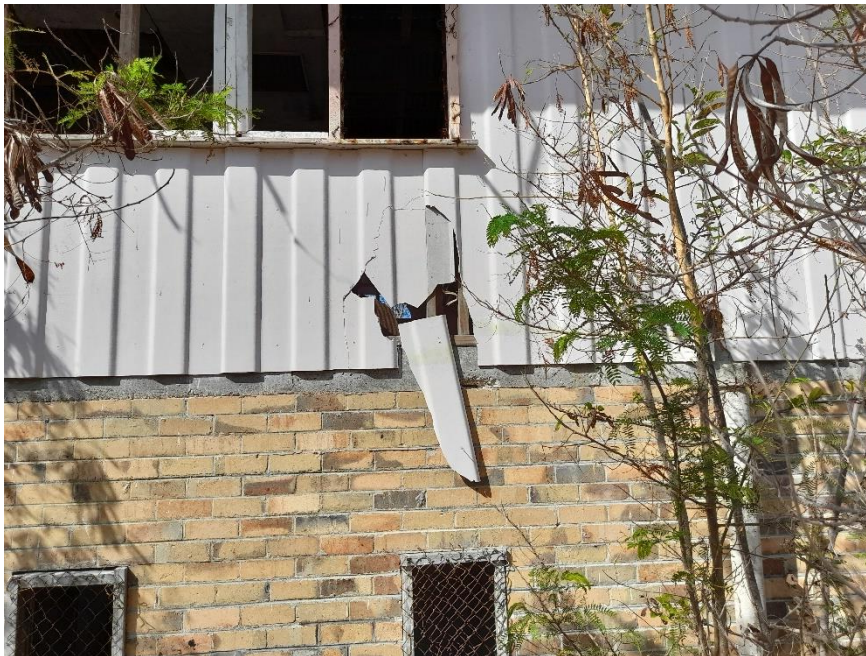
Figure 13. Broken exterior wall cladding at double storey - JSS

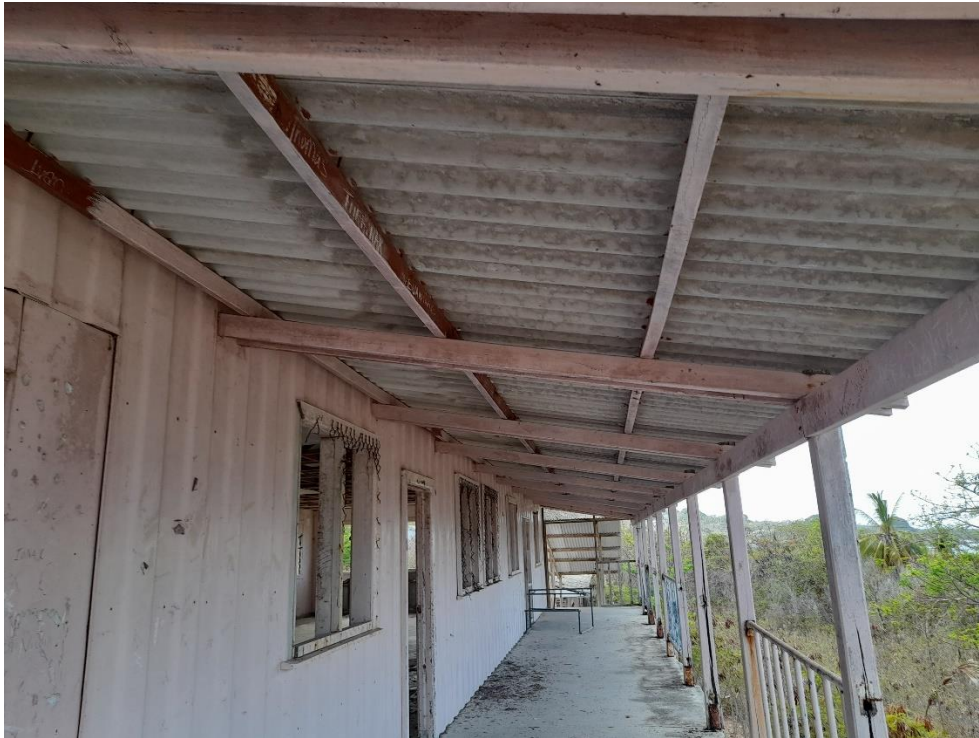
Figure 14. Varander on top of concrete building with ACM roofing

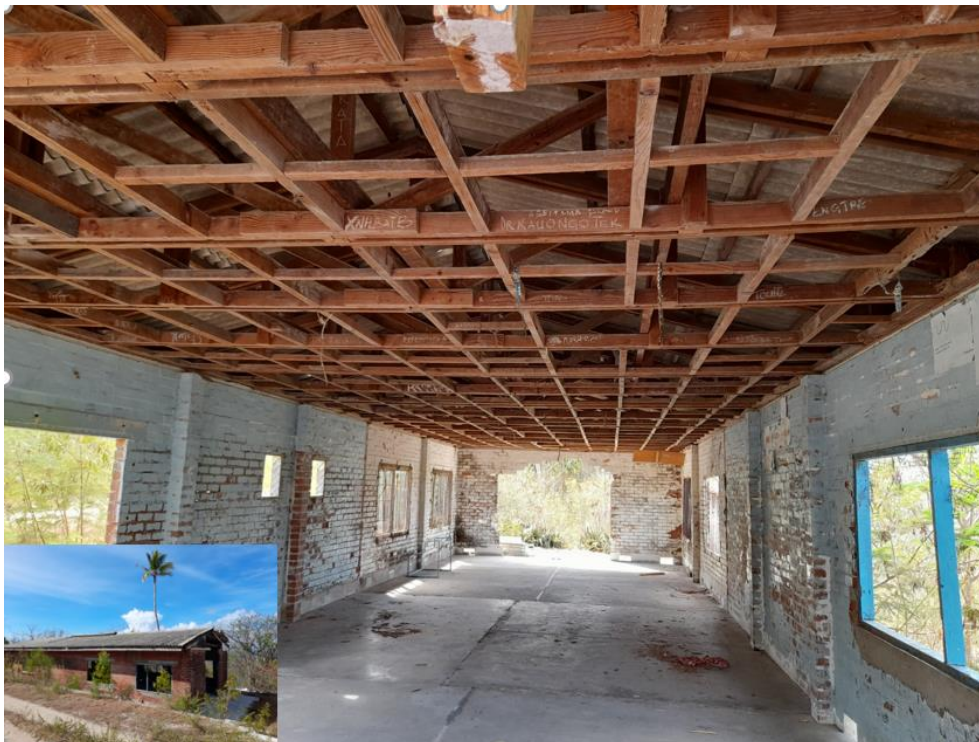
Figure 15. JSS former class; view from inside the building showing ACM roof

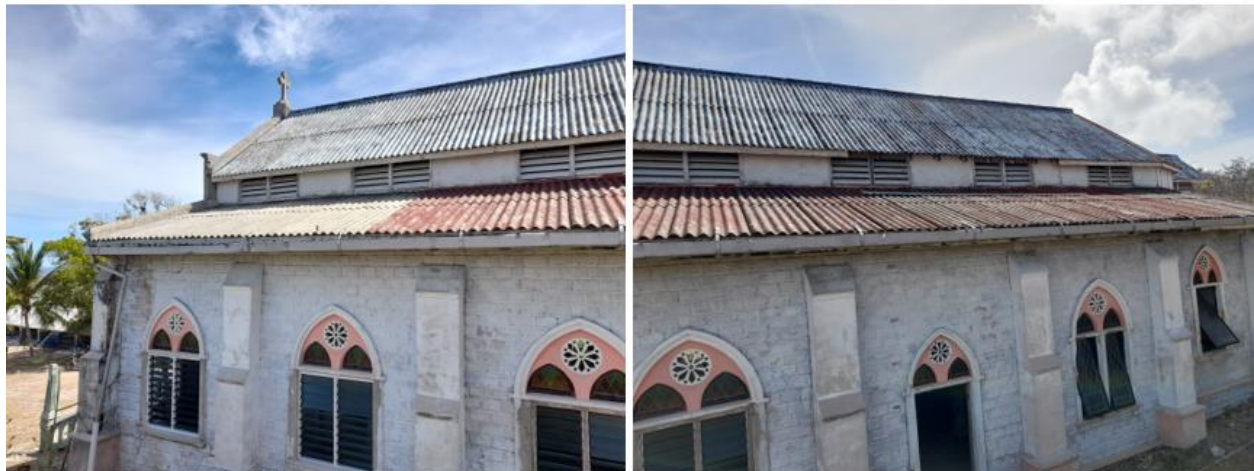
The results of the assessment confirmed that the only ACM found at Fatima Church is in roof and PACM used in internal cladding. Figure 18, shows the type of cladding used in the upper ceiling which is observed to be similar in type and color to that used in the pharmacy internal wall cladding. Both the roof and cladding are in good condition with no damage observed during the assessment.

Figure 17. Banaba Catholic Church in Fatima village with ACM roof

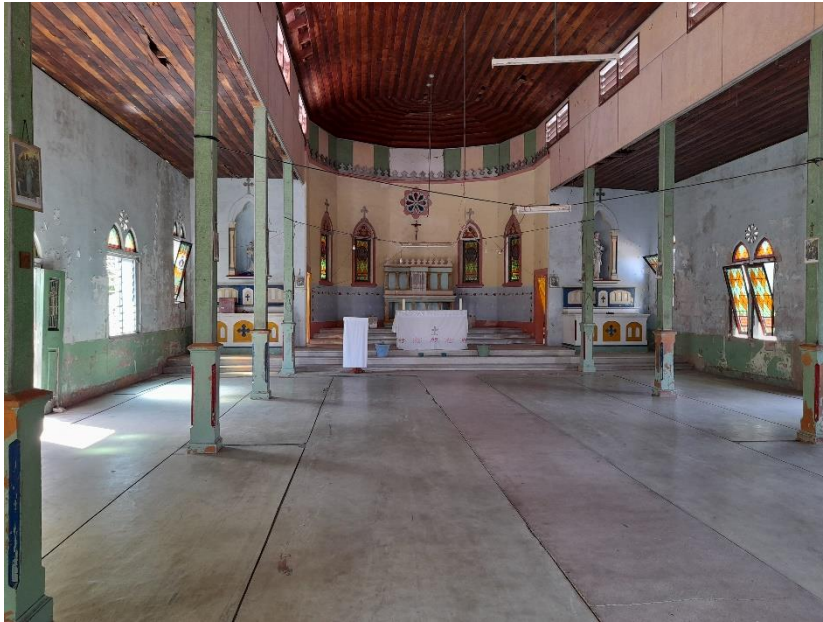
Figure 18. PACM use in church internal wall (above the concrete wall)
