## MOI WOF CENTRE (External car Parking)

MOI WOF CENTRE (Office building)

## MOI WOF CENTRE (Gas Station Building)

## MOI WOF CENTRE (Mechanical Workshop Building)

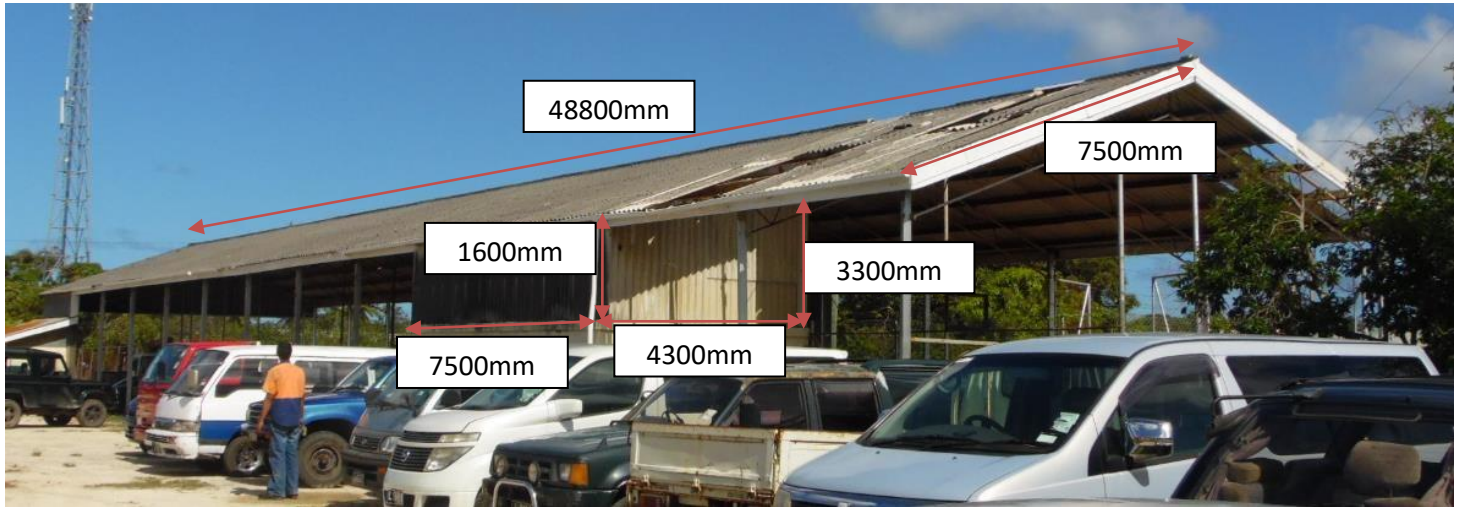
**Facia board:** 250x25mm timber were all rotten

**Guttering:** Spouting some were gone and some still in place with 6 downpipe as per pictures

**Purlin:** 7 purlins rows existing on one side, rotten and damage purlins and it will recognize while construction.

**Trusses:** some trusses detected rotten but it will be found out more while construction

**Soffit:** No soffit lining

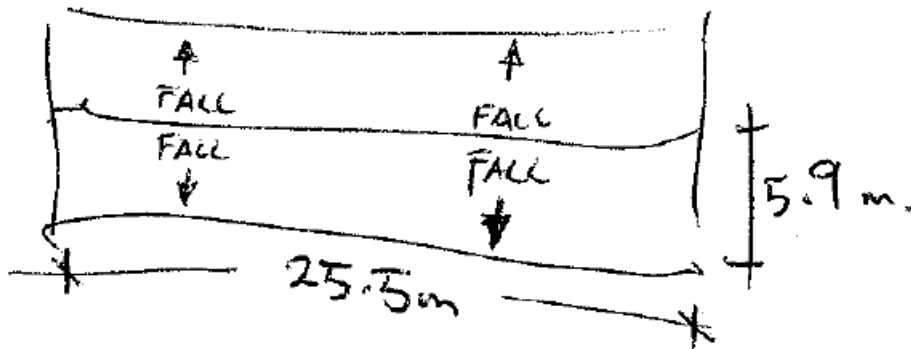
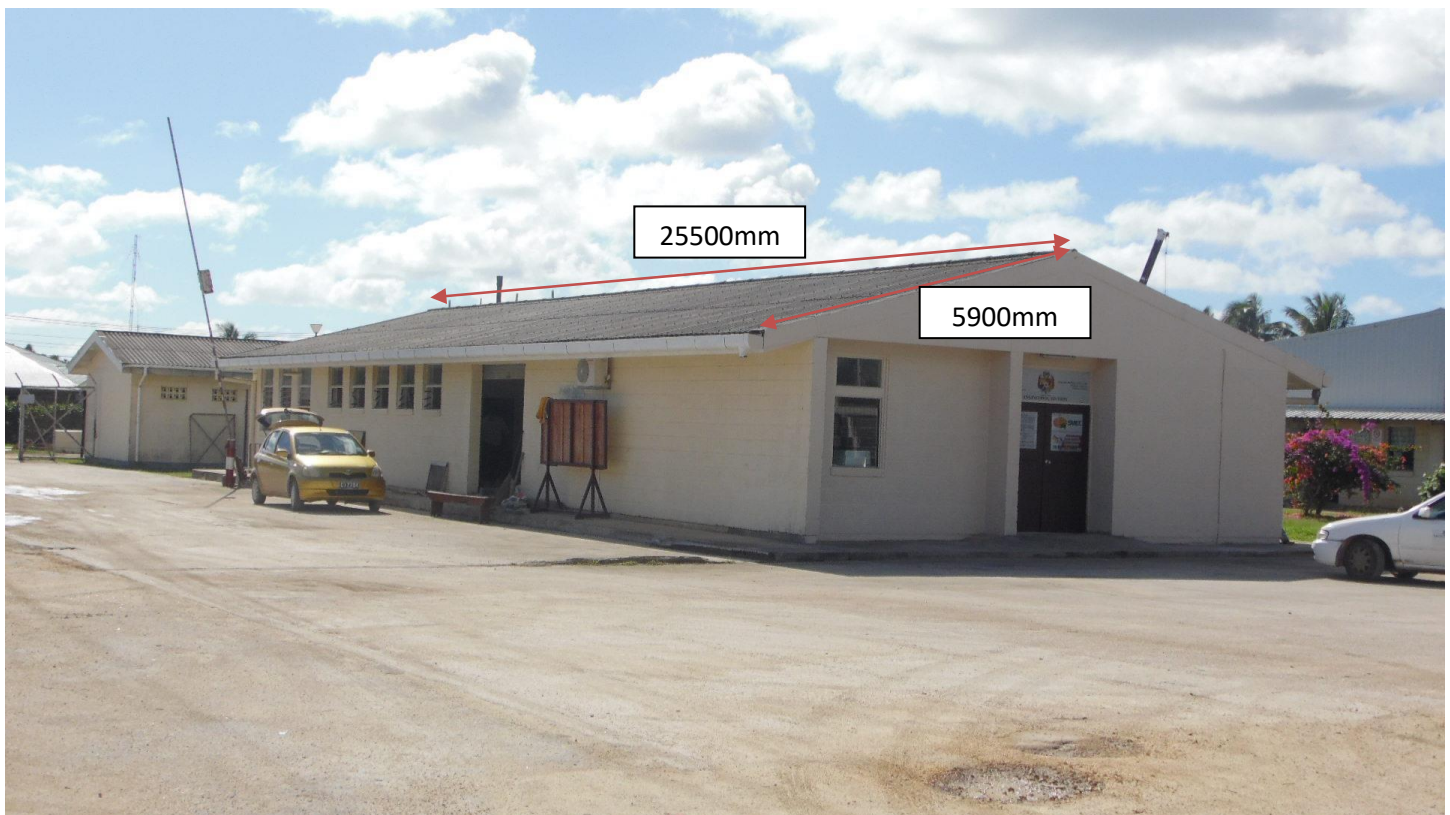
**Facia board:** 250x25mm timber will be recognize while construction whether it rotten or not

**Guttering:** Spouting were all asbestos materials with 4 down pipe

**Purlin:** 7 purlins rows existing on one side, rotten and damage purlins and it will recognize while construction.

**Soffit:** 900mm wide asbestos materials.

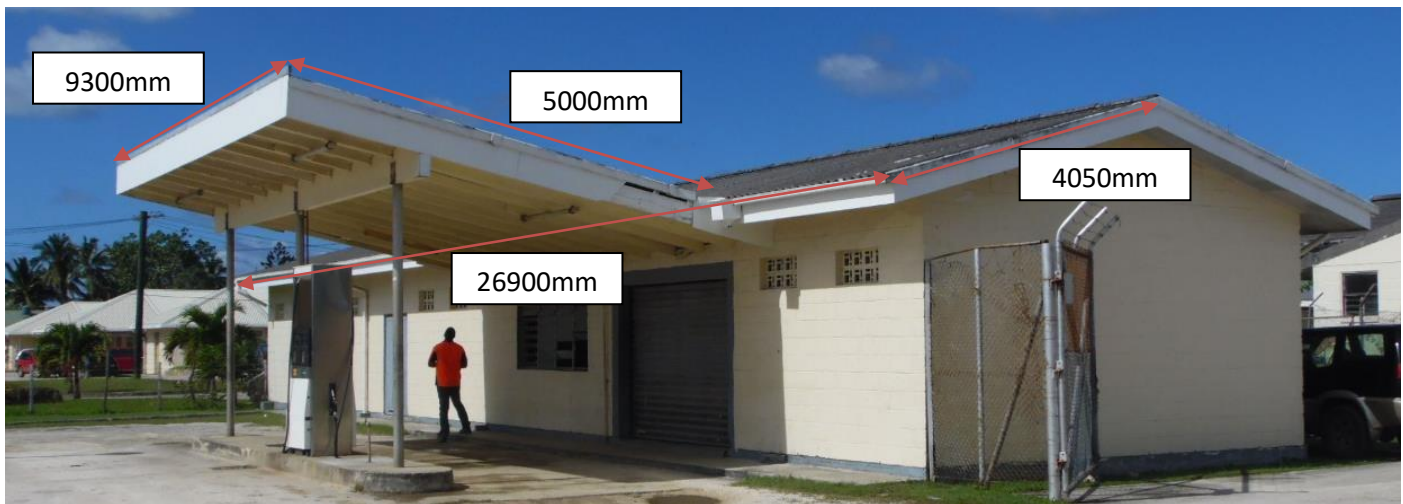
**Facia board:** 400mm wide asbestos

**Guttering:** Spouting still in place the internal guttering where both roof fall into is a asbestos

**Purlin:** 7 purlins rows existing on roof for petrol machine and 5 purlins rows on one side of cable roof, rotten purlins will be recognize while construction.

**Soffit:** 600mm wide asbestos materials.

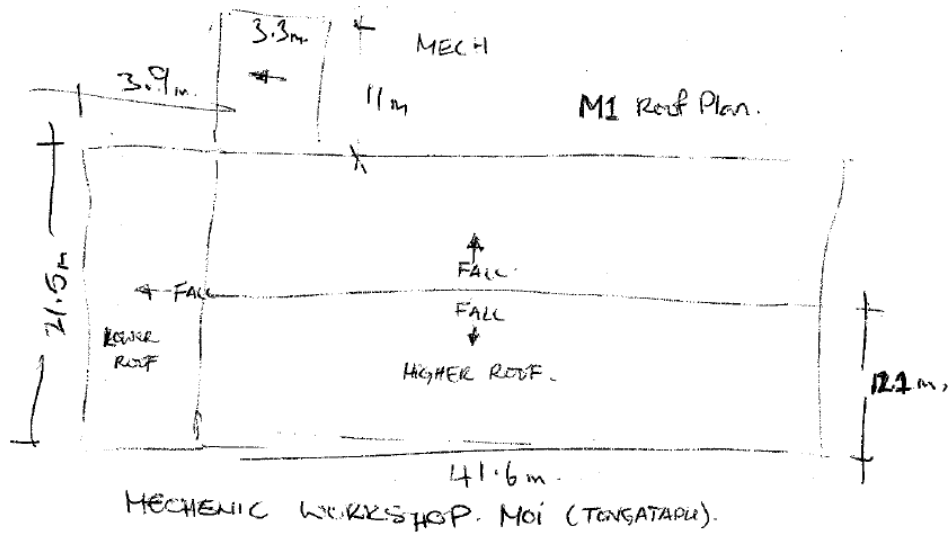
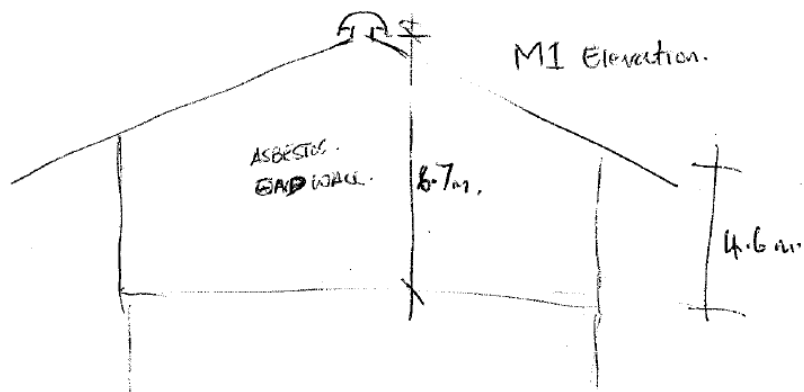
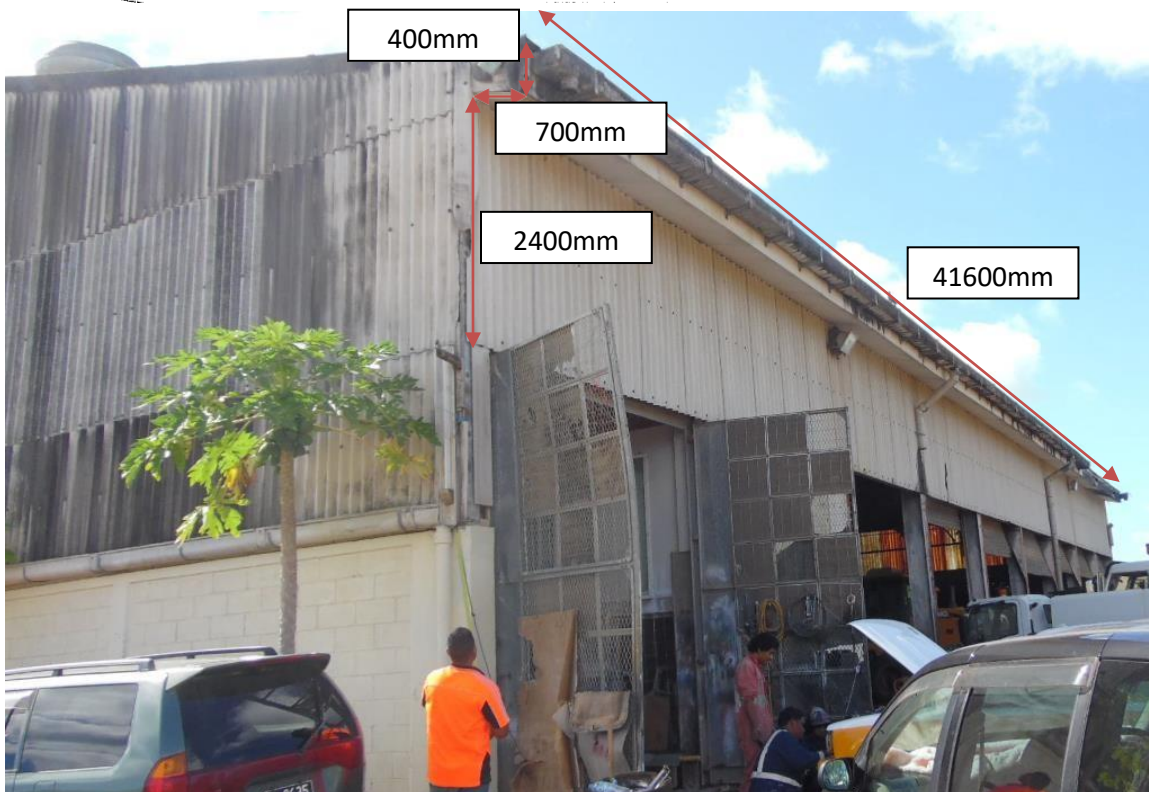
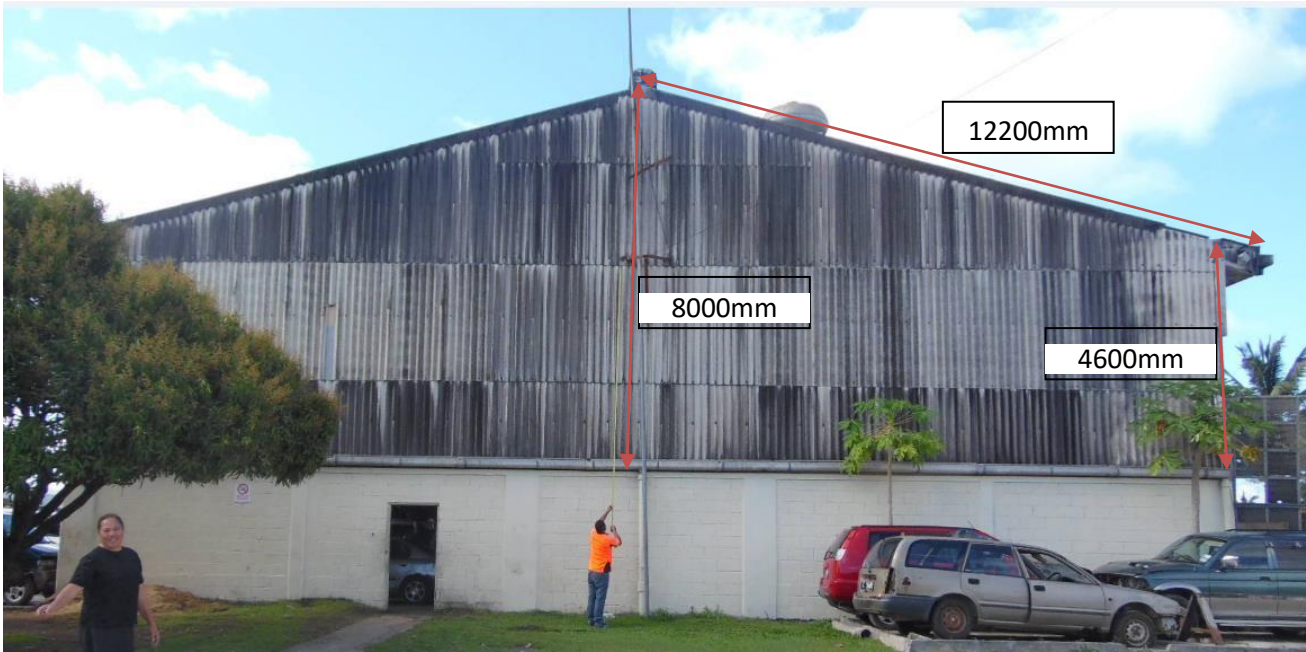
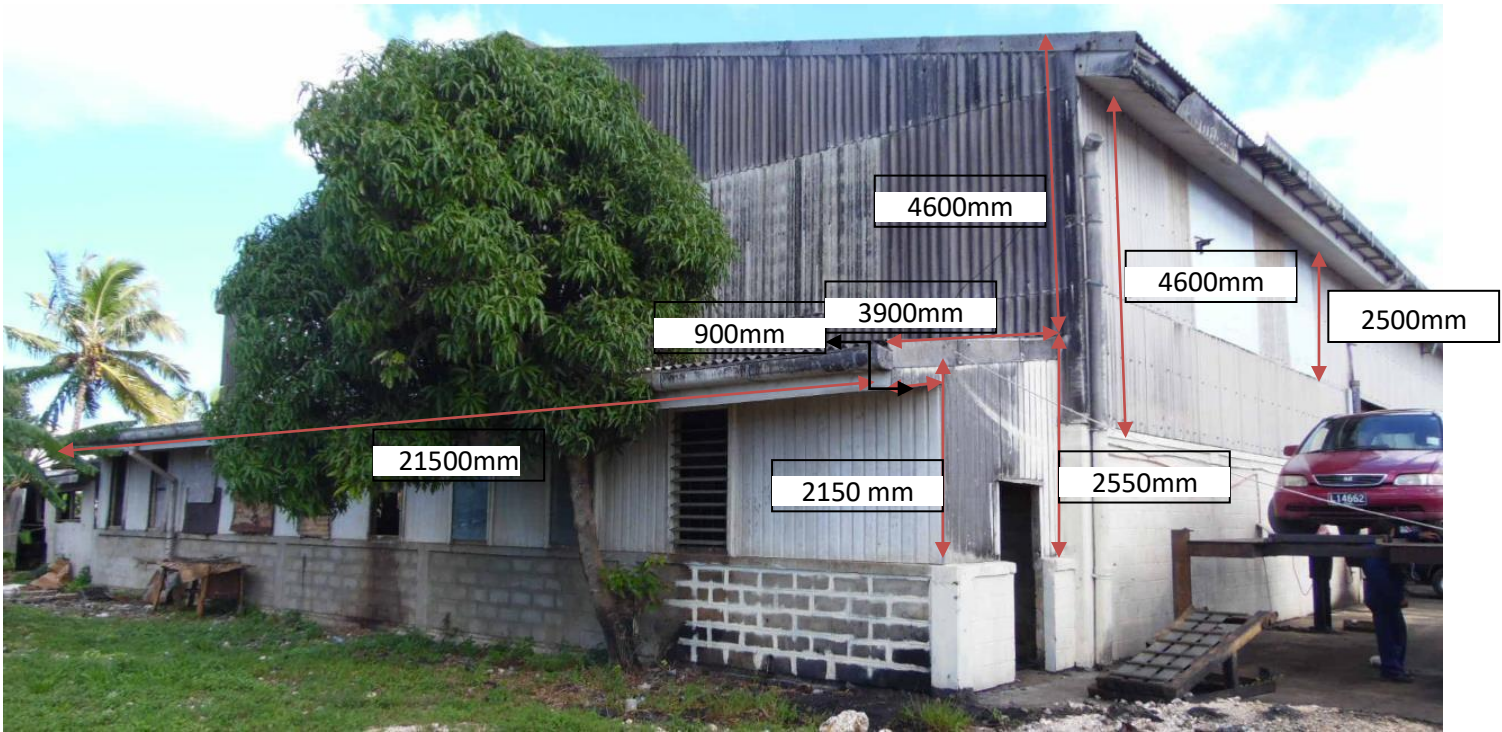
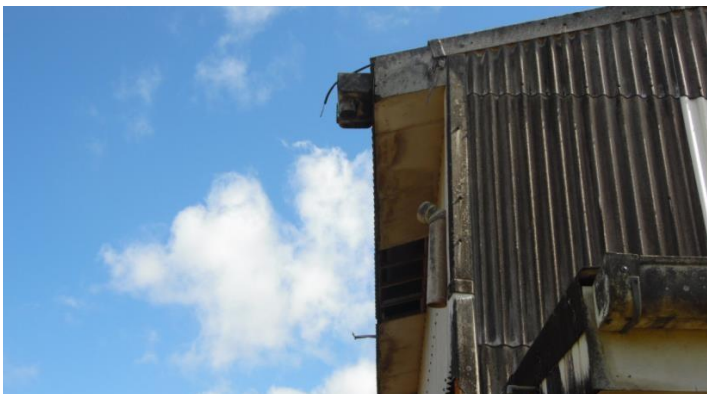
**Facia board:** 400mm wide asbestos

**Guttering:** Spouting were all asbestos materials

**Ridge Capping:** as per pictures that on apex there is a air ventilation with a half circle shade, workout from measurement as per above pictures and drawing

**Purlin:** 11 purlins rows existing on one side of cable roof. All rotten purlin will be recognize while construction.

**Soffit:** asbestos materials find measurement of drawing and pictures
