Banaba, Kiribati Asbestos Assessment

1. Background

On the 29 of May 2022, the Environment and Conservation Division Team conducted an asbestos assessment at the three priority buildings in Banaba. This was part of the Pacwaste Plus project administered by SPREP. The inspection was focused on three public buildings namely; Banaba Hospital, Junior Secondary School and Primary School and Fatima Catholic Church. The three buildings were selected based on the criteria for EU funding of Pacwaste Plus project. This was agreed by the ECD and Banaba team made of Island Clerk, MP – Tibanga Taratai, and Rabi Council of Leaders Island Manager Mr. Mwaroti Tamueru at the meeting held on the 2nd meeting 11 May 2022.

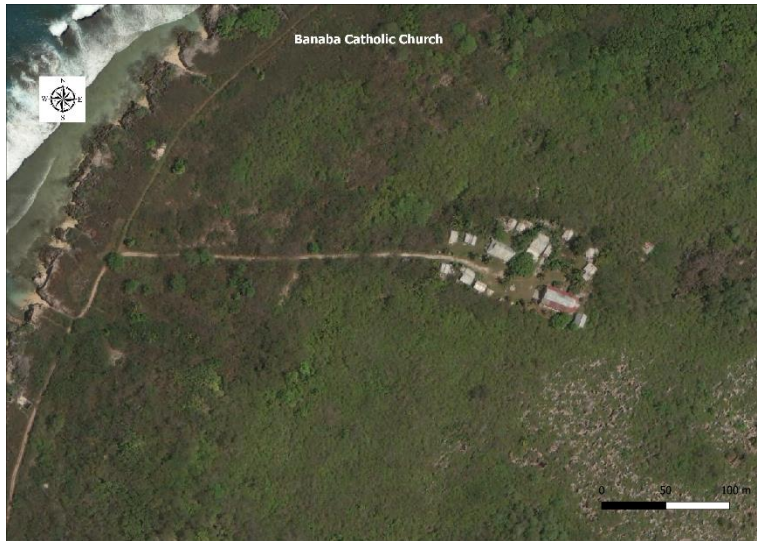
The church is located in high ground inland as shown in the photo figure 16.

Figure 16. Aerial view of Banaba Catholic Church showing it access from main road
